**Environmental and Social Incident
Impact Assessment Report for the
Tailings Dam Failure at Sino-Metals
Leach Zambia Limited**

18th December 2025

**Environmental and Social Incident Impact Assessment and
Recommendations for Remediation and Restoration measures
regarding the Tailings Dam failure incident at Sino-Metals Leach
Zambia Limited in Kalulushi District that led to the discharge of
acidic leach residue into the surrounding open environment, the
Chambishi Stream, Mwambashi and Kafue Rivers**

RFP- ZEMA/RFP/CS/21/08/2025

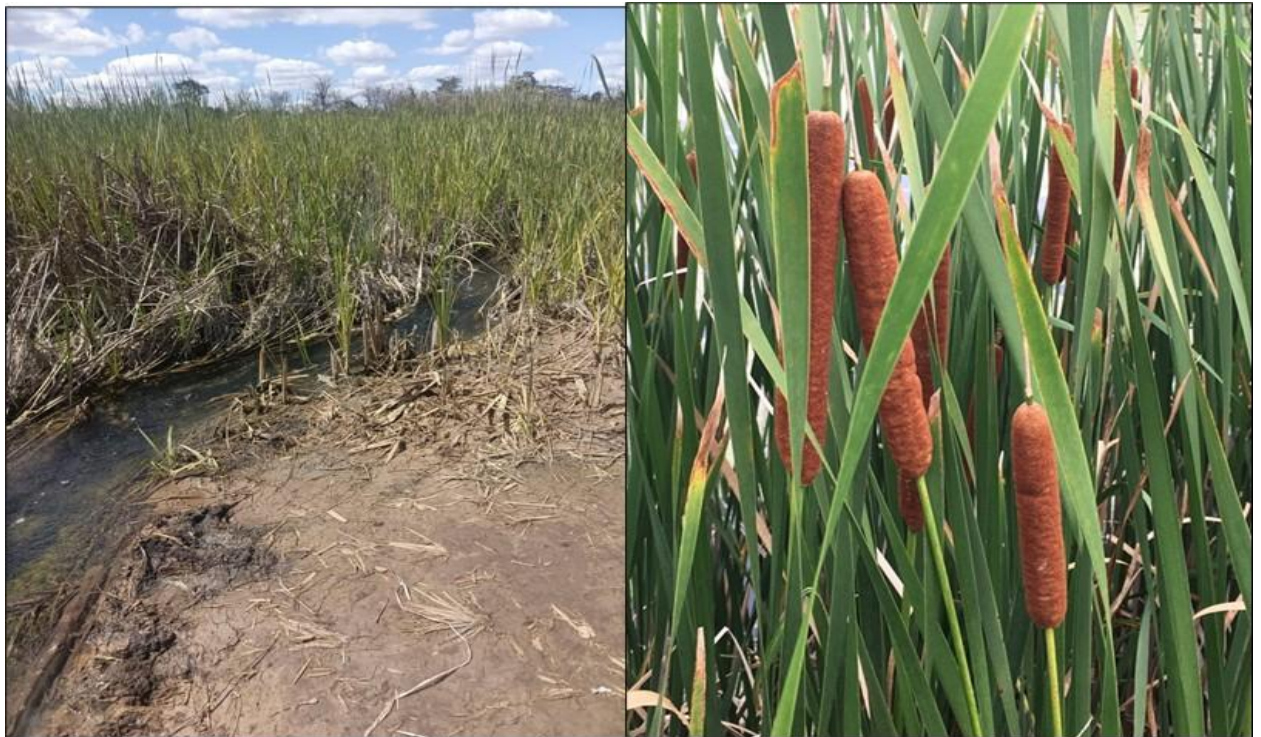
Figure 4-75: Photograph showing New Dam overgrown with Typha (left) and Typha flower¹¹(right)

The facility known as New Dam (shown on the satellite image in Figure above) is a low-lying wetland located on Chambishi Stream. The facility is completely covered with the aquatic weed Typha (Figure 4-75). New Dam has an inlet into the wetland and discharges to the environment through a v-notch weir (Figure 4-76). Effluent from Chambishi Metals, NFCA and Sino-Metals passes through New Dam before being discharged into Chambishi Stream through the v-notch weir. The New Dam functions as a Pollution Control Dam where contaminated water passing through the area is polished through sedimentation of particulates and uptake of dissolved minerals by weeds.

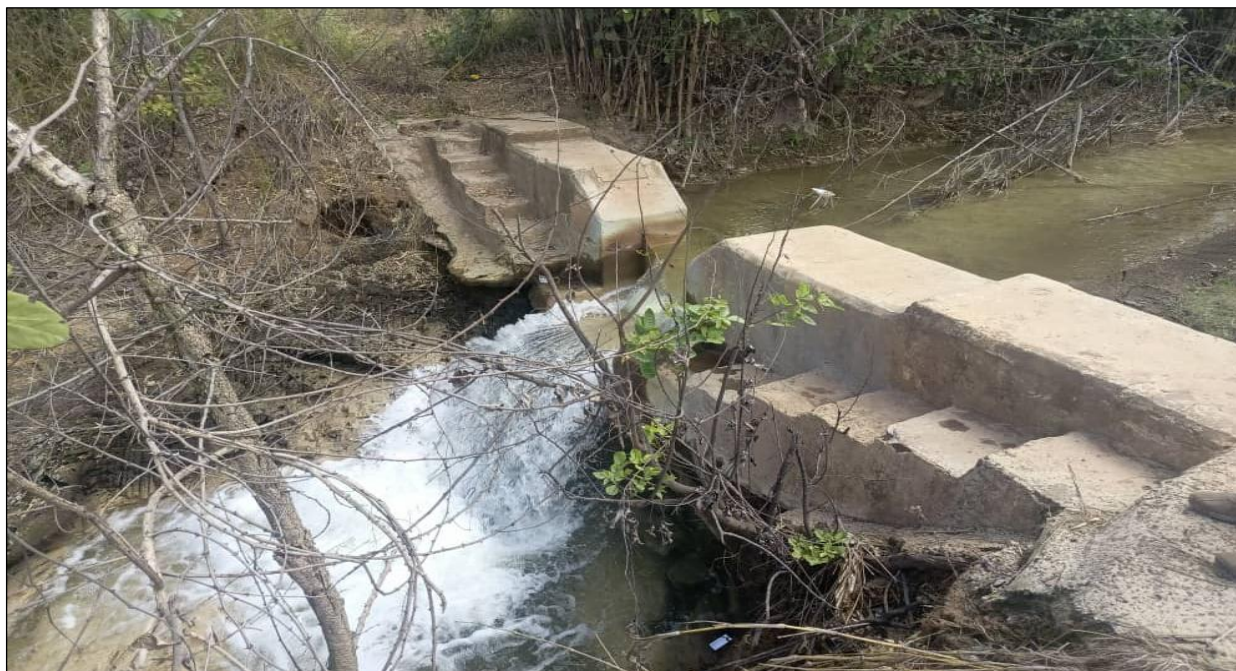
Figure 4-76: Photograph showing v-notch weir at the discharge from New Dam to Chambishi Stream

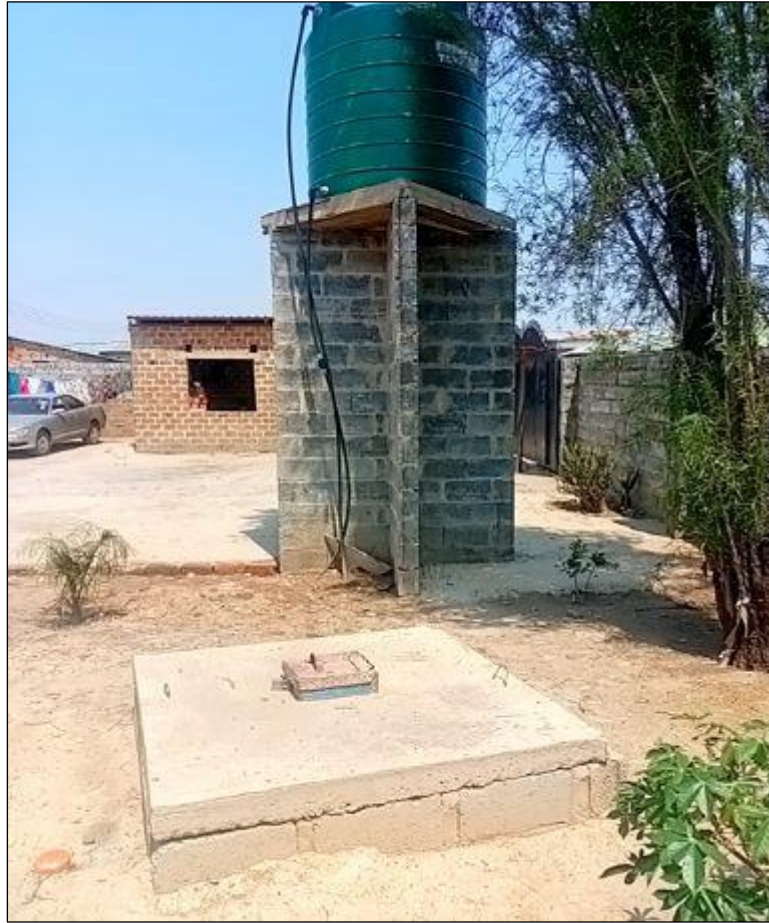
Figure 5-1: Photograph of a protected well in Luangwa Township

Groundwater is the primary source of potable water in the areas investigated. This is because the areas are not supplied with piped water by the local water utility, Nkana Water Supply and Sanitation Company (NWSC). Groundwater abstraction is mostly through shallow hand-dug wells, both protected well (Figure 5- 1 and Figure 5- 2) and unprotected (Figure 5- 3 and Figure 5- 4). Other groundwater sources identified in the area, especially in Kalusale, are what are known as scoop wells. Scoop wells are shallow excavations made near the streams, in the dambo areas where groundwater is shallow (Figure 5-5 and Figure 5-6. There is one borehole fitted with a hand-pump in Kalusale.

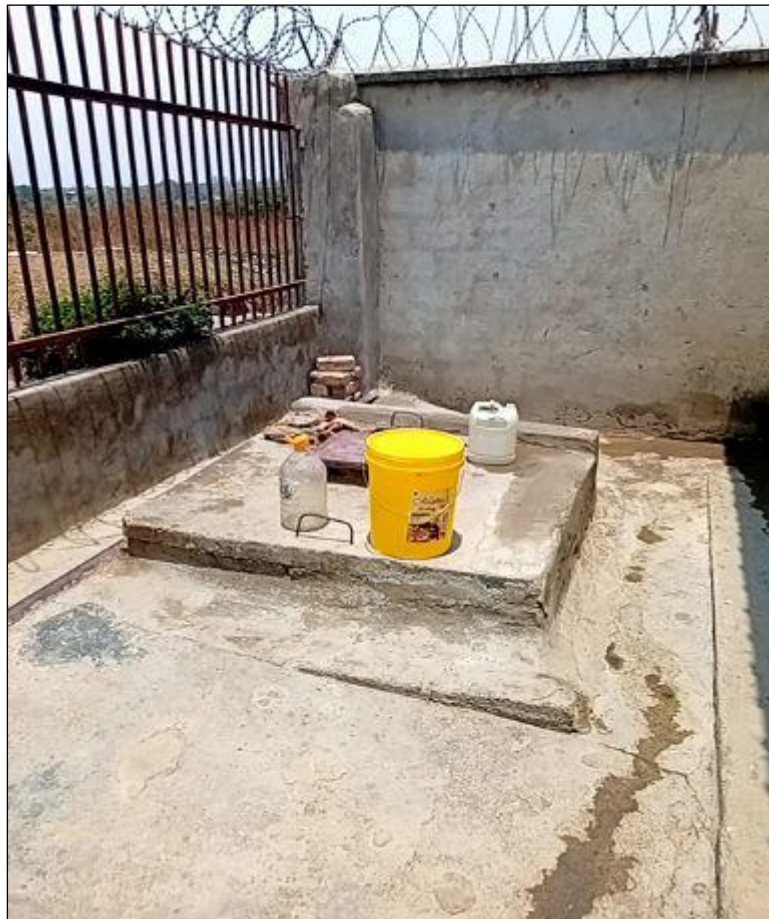
Figure 5-2: Photograph of a protected well in Luangwa Township

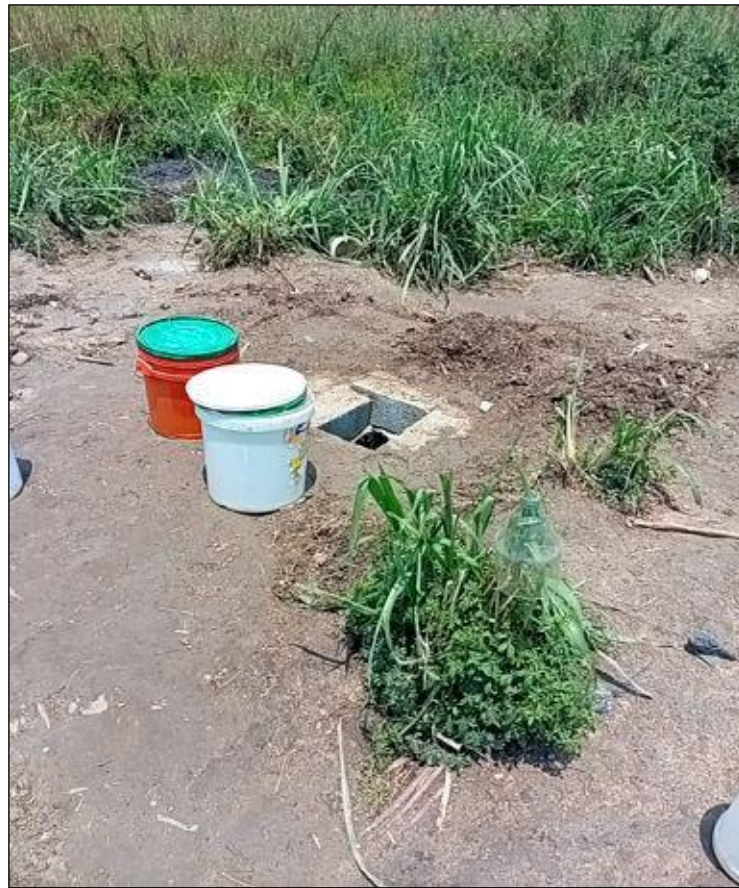
Figure 5-3: Photograph of an unprotected well in Luangwa Township

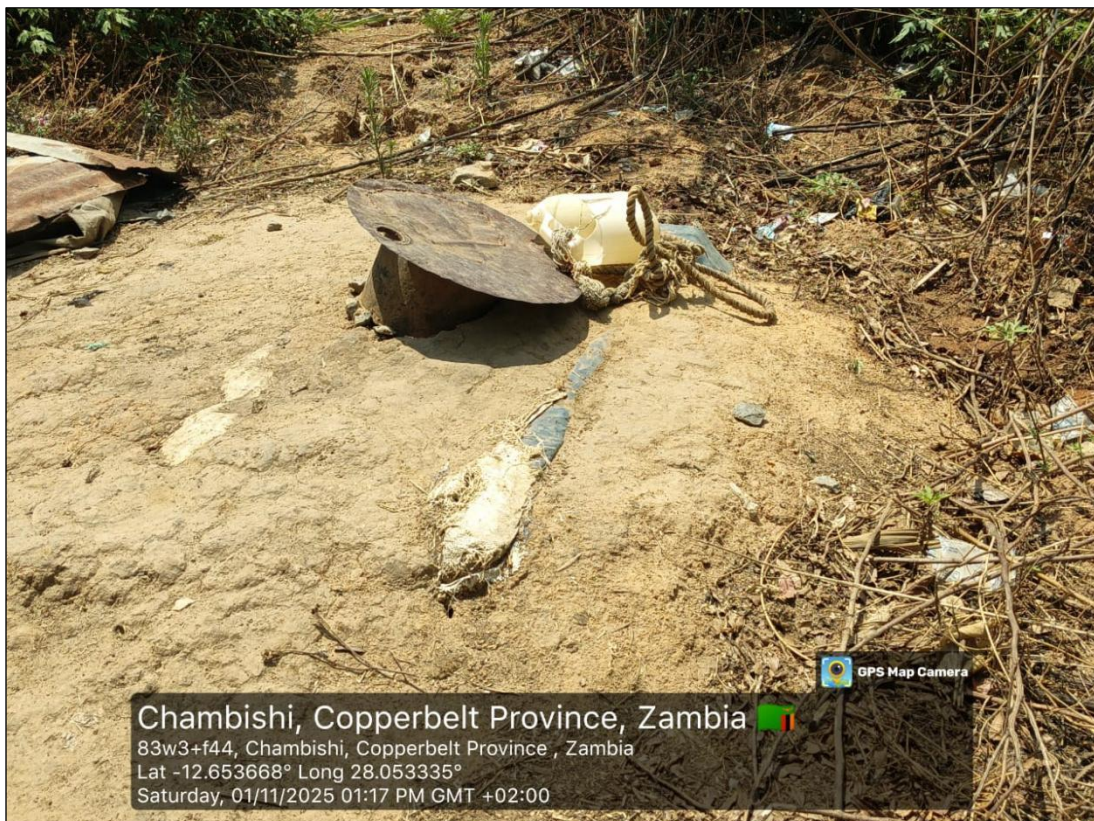
Figure 5-4: Photograph of an unprotected well in Kalusale

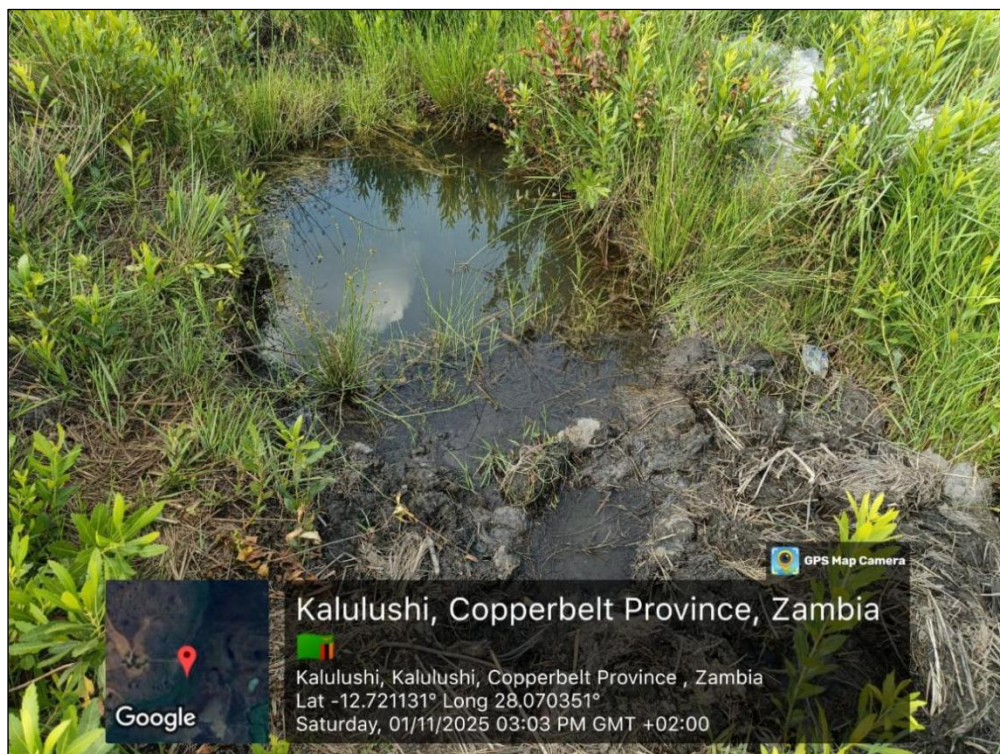
Figure 5-6: Photograph of a scoop well in the Kalusale area

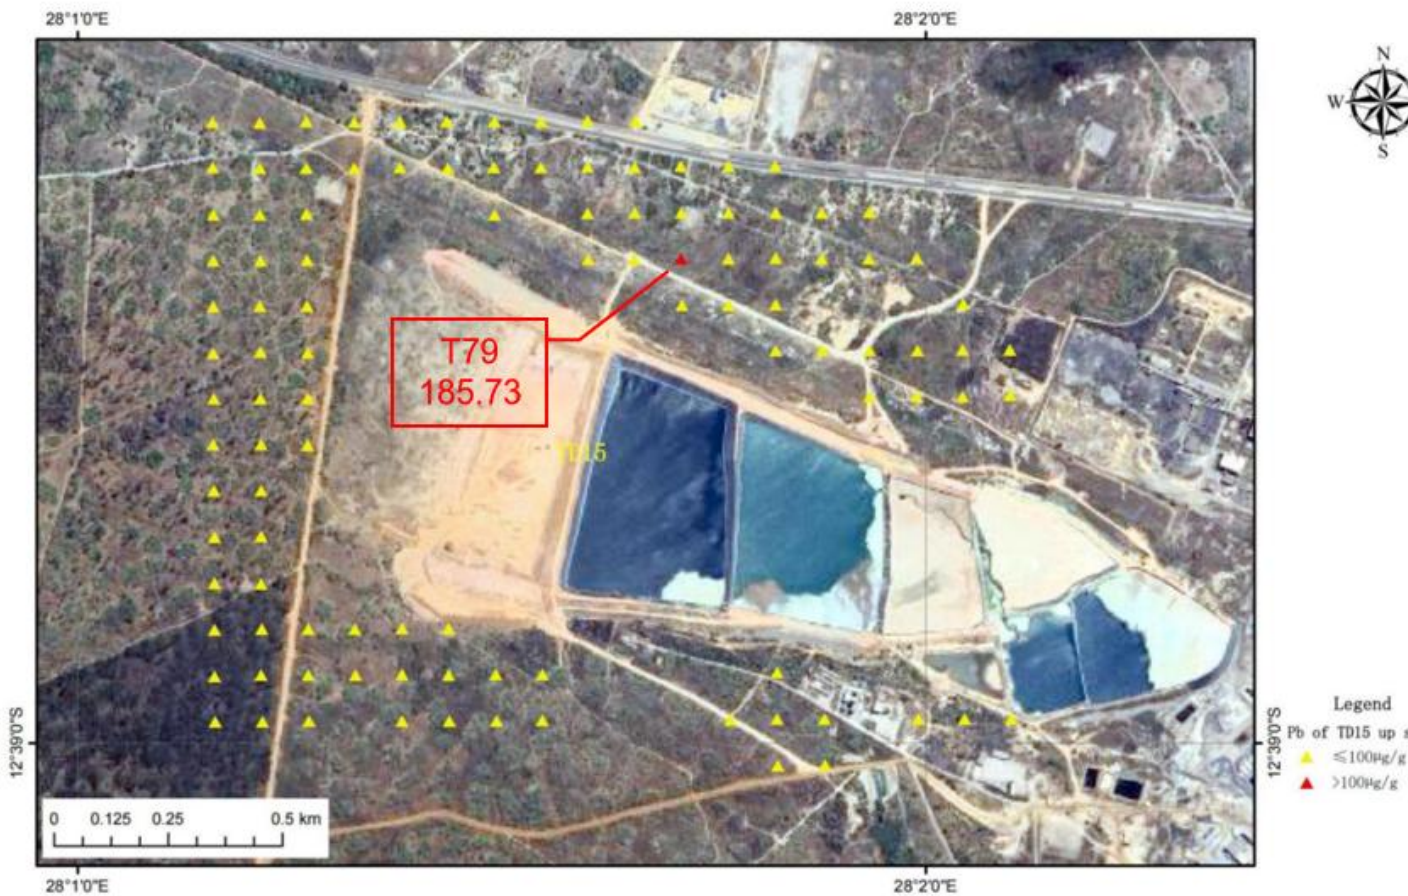
Figure 6–11: Distribution of Lead in TD 15

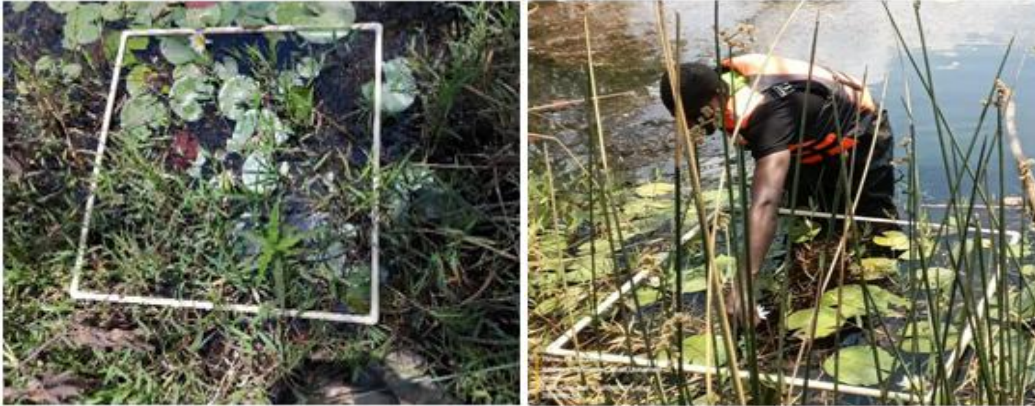
ACTIVITY	METHODOLOGY	OUTPUT PER SITE	TOTAL OUTPUT	FIELD PICTURES
<p>1. Macrophyte Quadrats</p>	<p>Three 1m² quadrats randomly placed per site; species identified, % cover estimated, and voucher specimens archived (non-lethal where possible).</p>	<p>3 quadrats</p>	<p>9 quadrats</p>

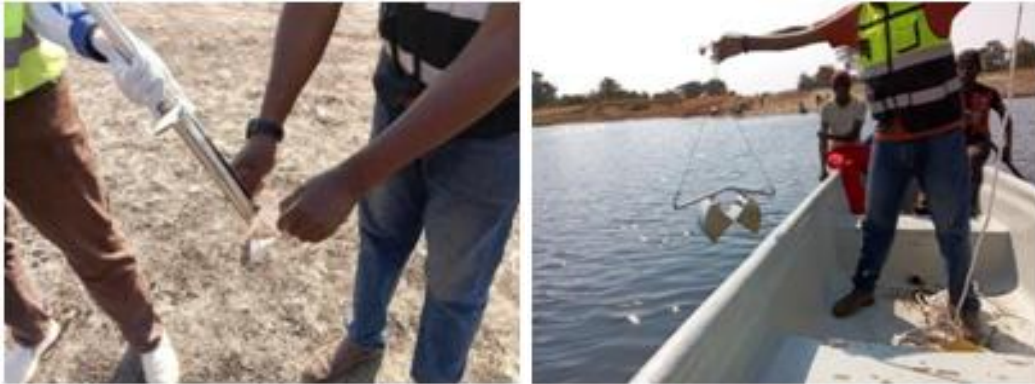
<p>2. Sediment Cores</p>	<p>Triplicate 15-cm cores collected using stainless steel corers; subsampled for metals (Pb, Cd, As, Cu, Zn, Fe, Mn) and grain size analysis.</p>	<p>3 cores</p>	<p>9 cores</p>

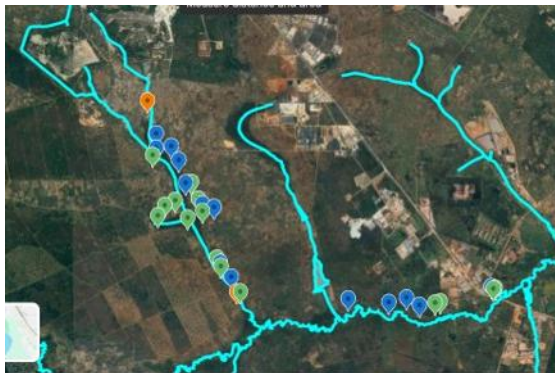
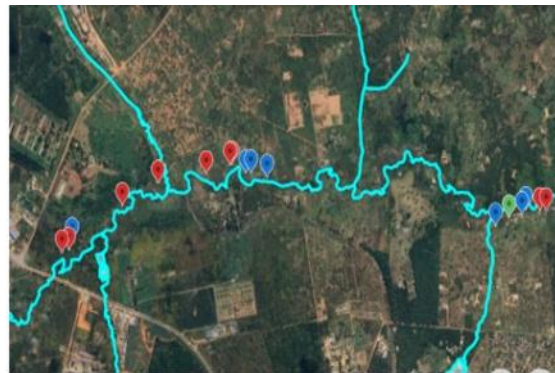
The figure below shows clear and uneven cobalt contamination across the study area. Severe hotspots (200–800 mg/kg), marked in red, are mainly concentrated along the Mwambashi River and are unsuitable for agricultural production, indicating influences from long-term mining activity or inherent geochemical conditions rather than the recent Chambishi spill. Along the Chambishi Stream, cobalt levels are elevated but lower (100–200 mg/kg), with no extreme hotspots observed. From an agronomic perspective, green areas indicate soils suitable for cropping without remediation, while blue areas require close monitoring and controlled crop selection. Orange and red zones are not recommended for agriculture and would require remediation or natural attenuation before safe use.

Chambishi Stream/ Mwambashi River- Musakashi Camp

Mwambashi River- Luongo Camp

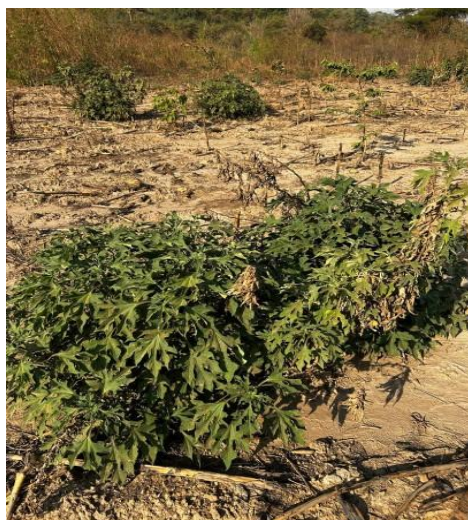
a) *Tithonia* thriving in a farmer's field where the tailings liquor passed Kalulushi

In the short term, heavy metal and sulphate contamination in agricultural soils generally causes physiological stress, uneven crop performance, and local yield reductions, which matches the patterns observed in the fields in Musakashi camp and Luongo Camp. Experimental and field studies indicate that high levels of Cd, Zn, Cu, and other metals can reduce germination, hinder root and shoot growth, and cause chlorosis and reduced biomass in cereals and root crops (Vasilachi et al., 2023; Shahriar et al., 2024). For instance, cassava grown in metal-contaminated soils in Nigeria experienced significant reductions in stem girth and dry matter yield even within a single season (Mmekam et al., 2025). Figure 8-4 shows that *Tithonia* can grow in areas directly affected by liquor in Musakashi camp. Figure 8-4b depicts a garden along the Kafue River in Ngabwe District where the farmer has been irrigating using water from the river.

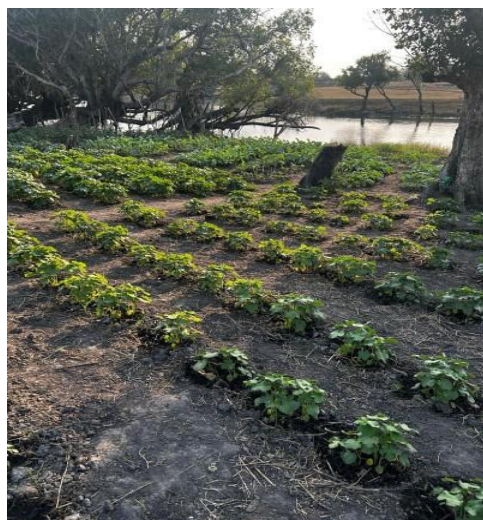
b) An okra field irrigated with water from the Kafue River-Ngabwe

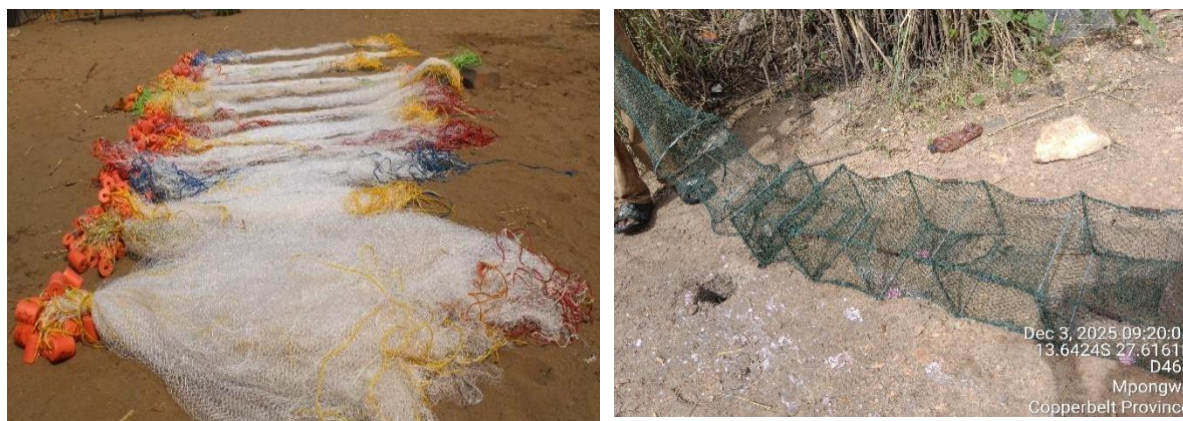
a. Fleet of experimental gillnets

b. Meshed fish trap

Data was collected using a mixed approach method; fishery independent and fishery dependent. In the fishery independent approach, a fleet of multi-meshed experimental gillnets (25,38,50,63 &76mm) was used, with different panels staggered on the fleet to overcome selectivity limitation of the gear. Further, gillnets were complemented by 25mm meshed traps (different from the traditional traps – *Imyono*) and handlines with hook sizes ranging from 1/0, to 4/0 (**Figure 11-2**). fishery dependent approach involved assessing and buying of fish species not encountered by the research team.
